# Failure of Morphology of $(0^\circ)_8$ Graphite/Epoxy as Influenced by Environments and Processing

Linda L. Clements and Michael J. Adamson

August 1981

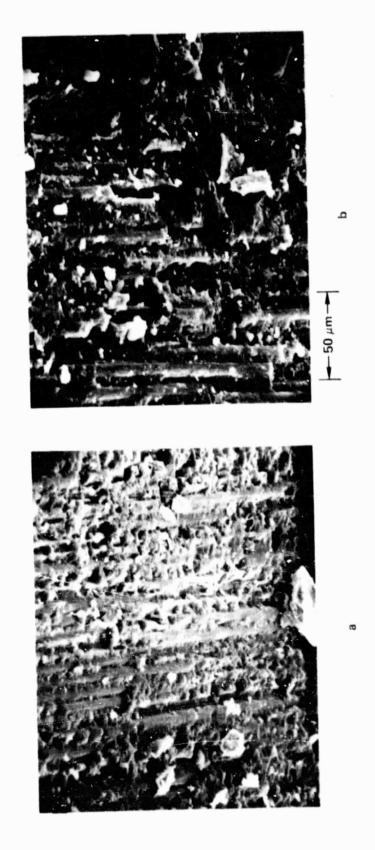
edges. Figure 2 compares a typical scanning electron micrograph of a polished edge (Fig. 2a) to one of an unpolished edge (Fig. 2b). While the polished edge has individual damaged filaments, the unpolished edge shows numerous areas where groups of filaments are damaged. An examination of specimen failure mode revealed the apparent effect of these groups of damaged filaments on the failure of unpolished-edge specimens. More than 60% of the specimens with unpolished edges failed by low-energy failure propagation, and the balance failed at the tabs or by splitting and delamination. On the other hand, more than 70% of the specimens with polished edges failed by high energy or mixed modes; few failed by low-energy failure propagation. We conclude that the damaged edges of the unpolished-edge specimens constituted defects which produced the low strengths observed.

Figure 2.- Scanning electron micrographs comparing appearance of (a) unpolished to (b) polished specimen edges.
